Last month's report by BP into the causes of its Gulf rig explosion and fire, and the lessons to be learned, points to a chilling sequence of failures. Brian Tingham reports

Deepwater

Horizon

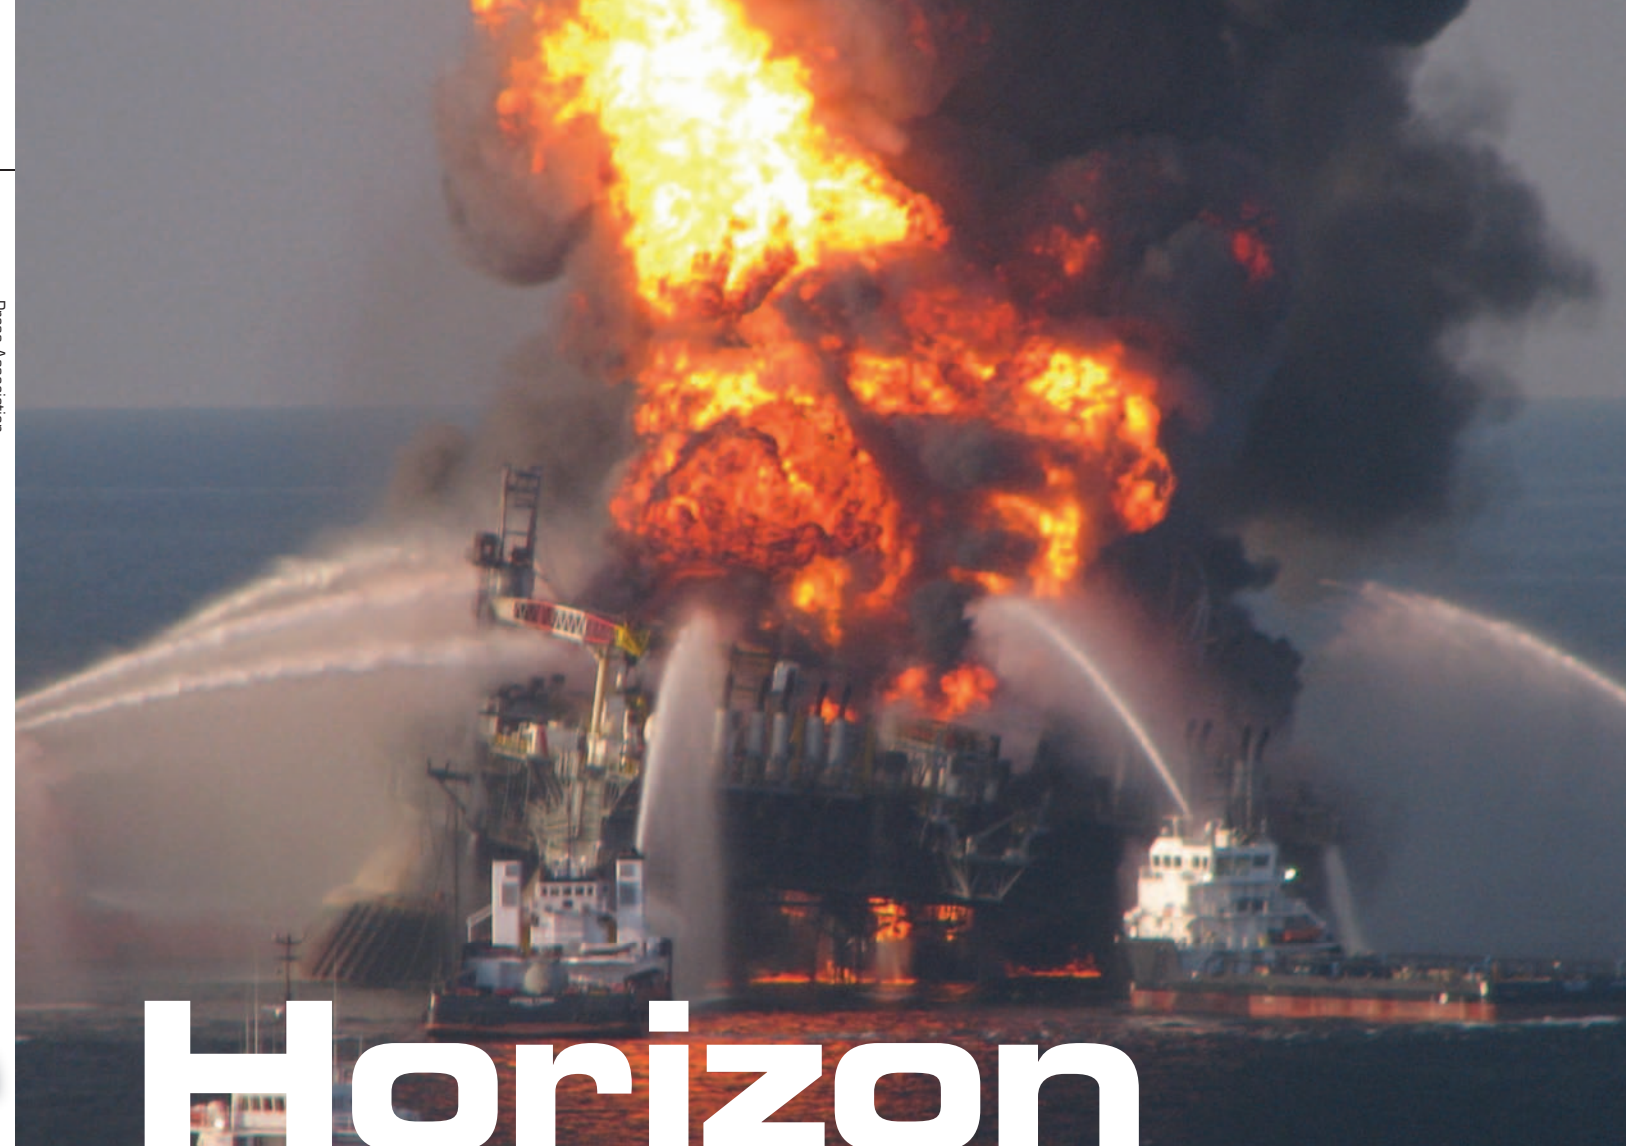
The immediate aftermath of the Macondo well tragedy, as seen by the US coastguard
