The Flixborough disaster happened 33 years ago, but with Buncefield uppermost in plant engineers' minds, last month's extraordinary re-run was telling. Brian Tinham reports

revisited

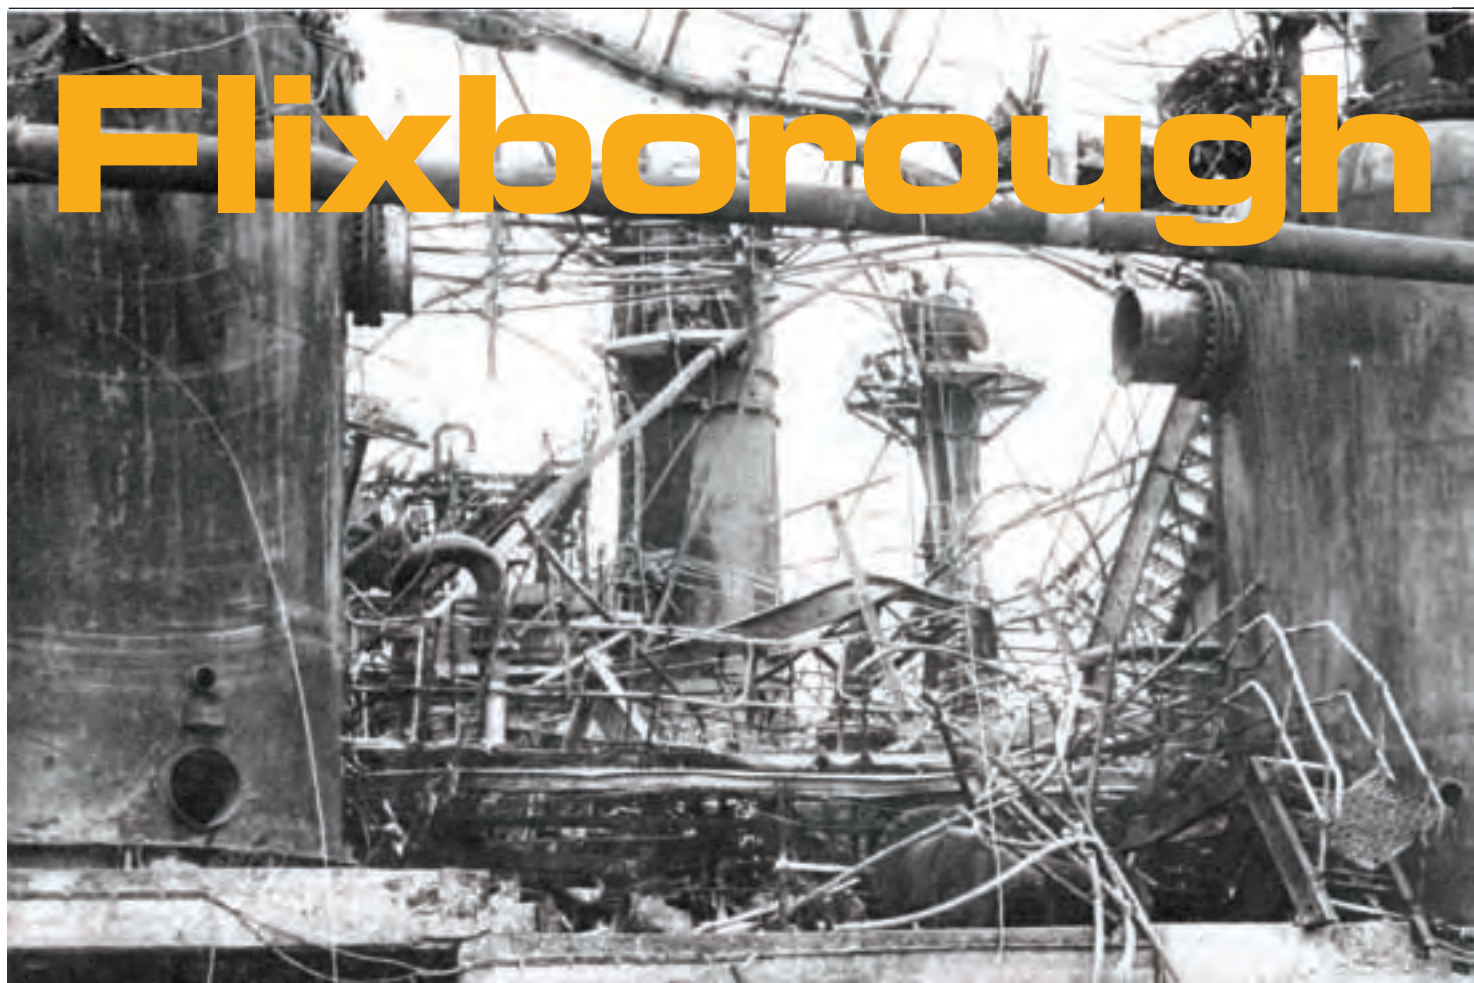
Left: The space between Reactors 4 and 6 after the explosion – with its 20 inch Reactor 5 bypass line missing
Below: The 8 inch banjo line elbow, with its 50 inch rupture – thought to have produced the devastating flame that led to the catastrophic explosion

First, a little background. The 20 inch dogleg line had been installed, with bellows at either end and supporting scaffolding, to bypass the fifth of a six-reactor chain on the section of plant processing superheated, pressurised cyclohexane. Reactor Five had been removed two months earlier in a plant shutdown, because of cracks found leaking cyclohexane. Astonishingly, no investigation was apparently performed on the other five reactors.

Venart's view of events is quite different, focusing on an internal tear in the bellows at the Reactor Four end of the 20 inch dogleg line as the key to the event. He insists that poor design and mechanical engineering ignorance led directly to failure of first this bellows, then the pipe jackknife,

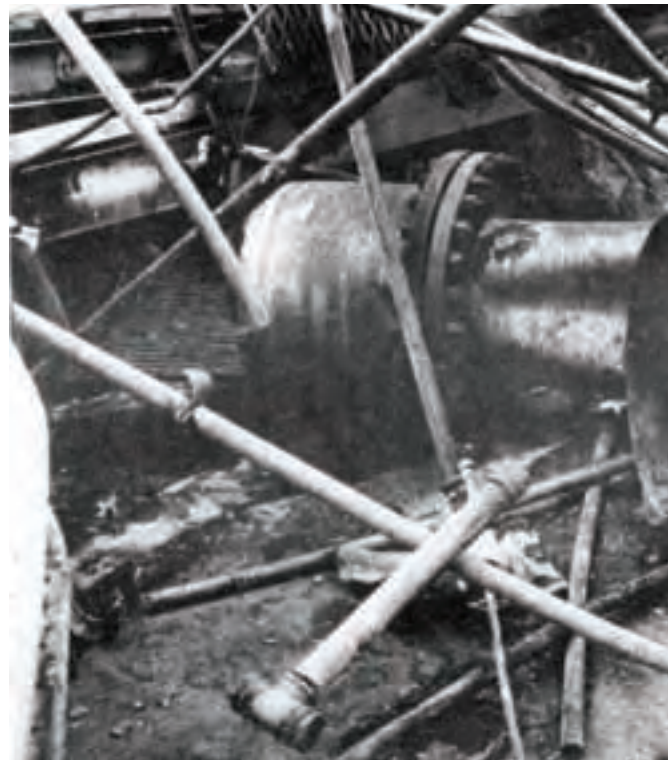
The metallurgical studies show rapid creep failure at the pipe elbow, which had happened without torsion (so before being twisted by the main blast), along with swelling – resulting in a 50 inch split. It was consistent with that elbow being subjected to a localised pre-event intense flame. But from where? From the bolt cage and intrados to which the banjo was connected – that was found with bolts loose and gaskets missing. Says Cox: "The investigators at the time recorded: 'There is some evidence that the [pipe] assembly and maintenance of its joints had not been good.' But Nypro had asked me not to pursue evidence that made it appear that the company was shifting the blame."

Cox believes the additional energy came from a prior unrelated explosion and intense flame jet from a burst elbow on a nearby eight-inch banjo line also carrying cyclohexane, but at 9bar. And he cites evidence for that pre-event from several witnesses – misinterpreted or omitted at the time, but confirmed by one at last month's conference. That event was the trigger, he says, for the 20 inch line's demise, the massive fuel ejection, rapidly expanding vapour cloud and consequent catastrophic blast.

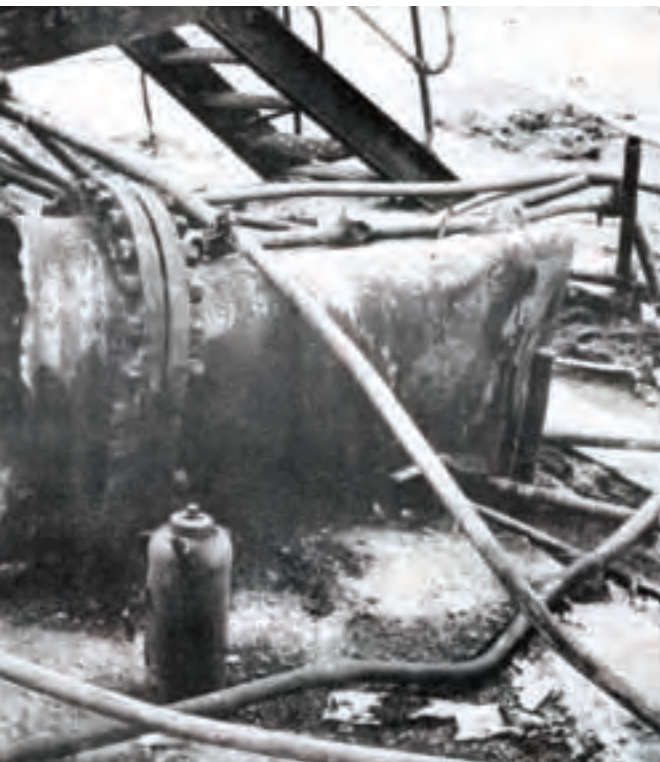
Left: The jackknifed 20 inch dogleg bypass line after the explosion – grounded between Reactors 4 and 6

The thinking here hinges on the unstable, inadequately guided bellows and pipe, which, he says, would have been locking down and extending either bellows end alternately – meaning that only half the force calculated at the original inquiry was required to rip off the already damaged end. Also, once torn off that reactor, the pipe, being forced upwards, would have jackknifed within 140msec, causing an immediate surge in Reactor Six, similar to huge water hammer – so accounting for the recorded baffle and stirrer damage.
